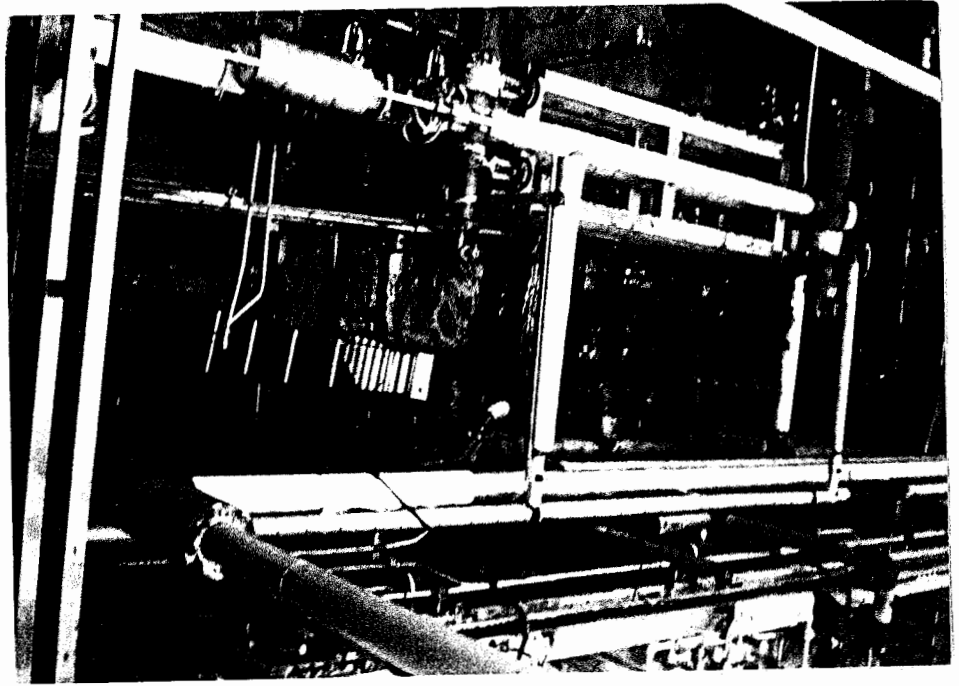
- 1.1 Tank No. 1 Receiving Tank; Tank No. 2 Receiving Tank;
 2.1 Tank No. 3 Receiving Tank; Tank No. 6 Collection and
 3.1 Transfer Tank. View looking down into the transfer pump
 6.1 area for Receiving Tanks 1, 2, and 3 at the Solid Waste
 Facility (SWF). The concrete wall for the Receiving Tanks
 is visible to the right of the valve area. SWMU 6 is
 located at the top of the photograph.

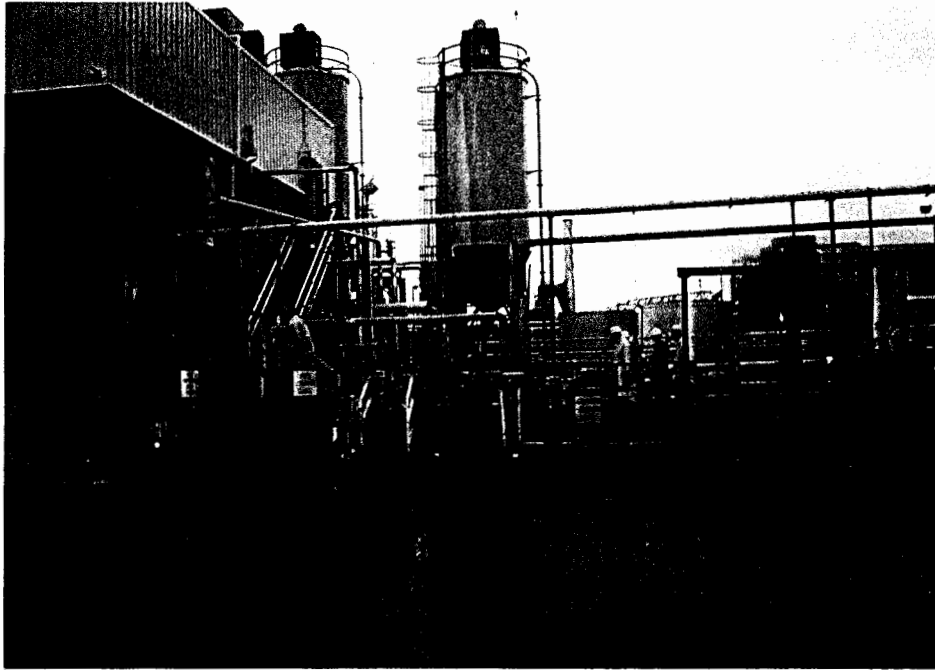
- 1.2 Tank No. 1 Receiving Tank; Tank No. 2 Receiving Tank; and
- 2.2 Tank No. 3 Receiving Tank. View facing north toward the
- 3.2 Solid Waste Facility. The loading area in the foreground is
- the Sludge Receiving Trough (SWMU 19). The south wall of
- SWMUs 1, 2, and 3 is visible beneath the walkway in the
- photograph.

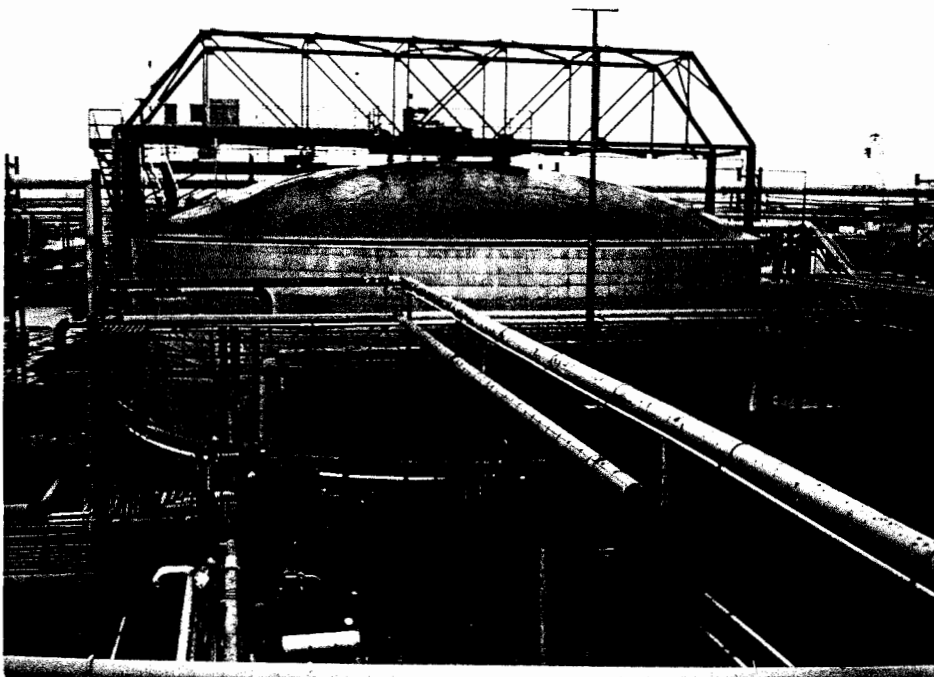
- 4.1 Tank No. 4 Sludge Storage Tank. View facing east. Note the
- transfer pipes from the receiving tanks.

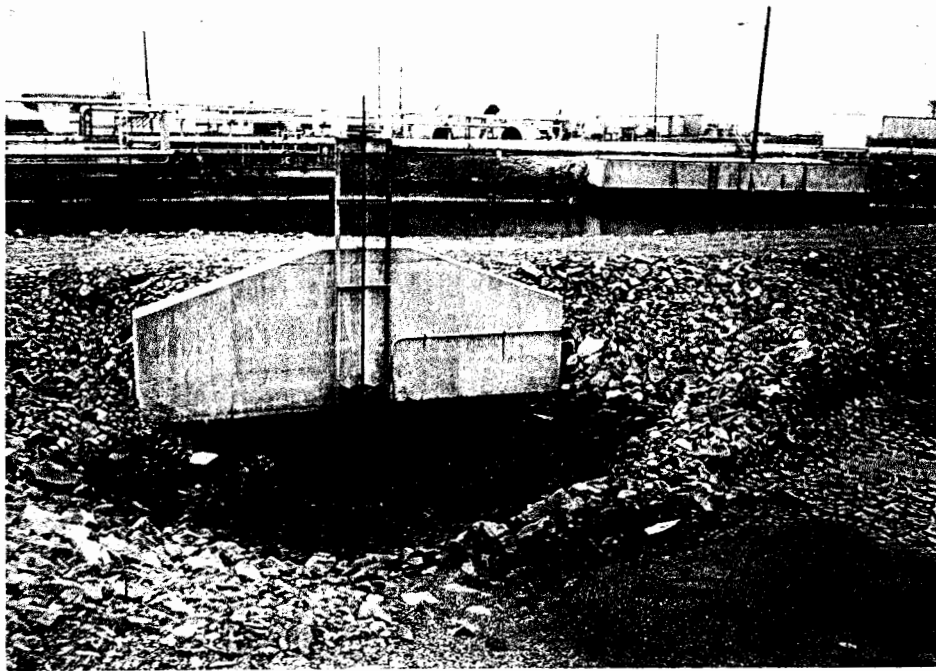
- 4.2 Tank No. 4 Sludge Storage Tank. View facing south of the storm water release valve for the containment area surrounding SWMUs 4 and 5 (and the creek beyond). The valve was open at the time of the VSI. Note staining on the surrounding gravel and soil.

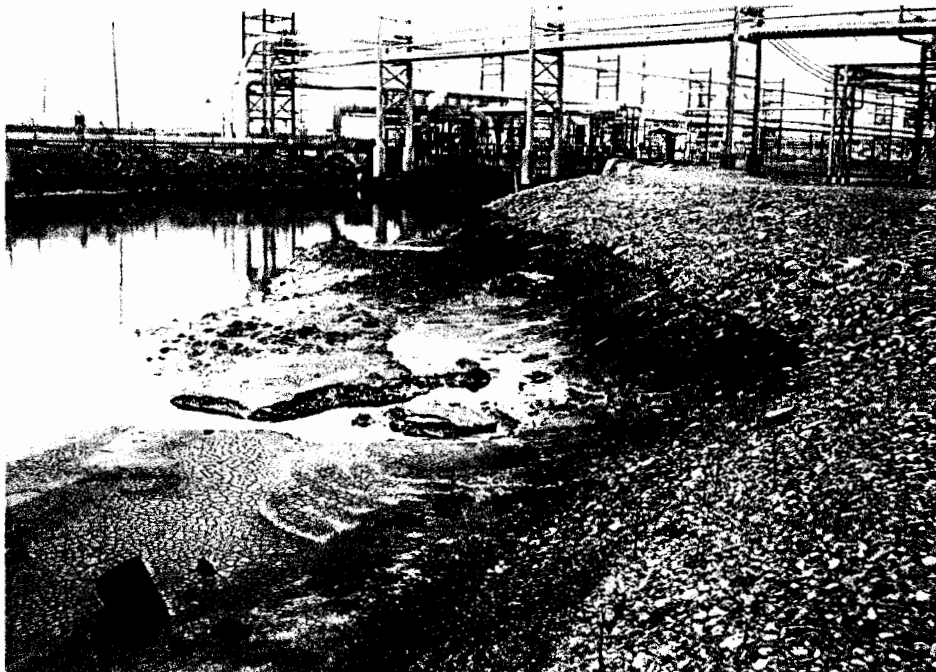
- 4.3 Tank No. 4 Sludge Storage Tank. View facing west showing the discharge pipe from the containment area for SWMUs 4 and 5. The pipe is visible in the very dark stain along the banks of the creek to the right in the photograph. Note the sludge accumulation in the creek.

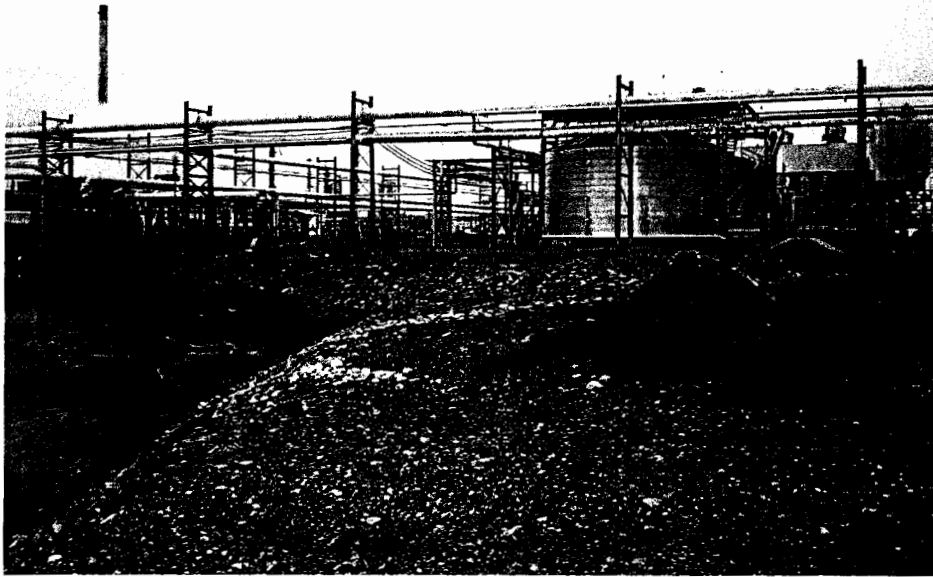
- 4.4 Tank No. 4 Sludge Storage Tank. Overview facing west showing SWMUs 4 (behind) and 5 (front) and the area in the Middle Creek Surface Drainage System (SWMU 96) where discharges from the tank containment area are routed. Note sludge accumulation in the creek.

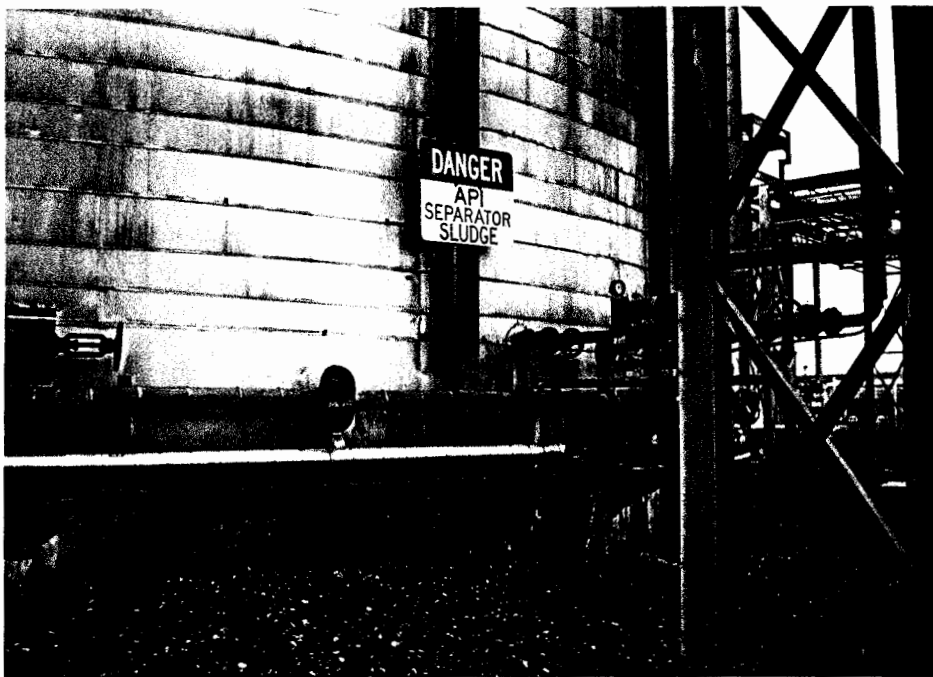
- 4.5 Tank No. 4 Sludge Storage Tank. View facing north. Note staining on tank foundation.

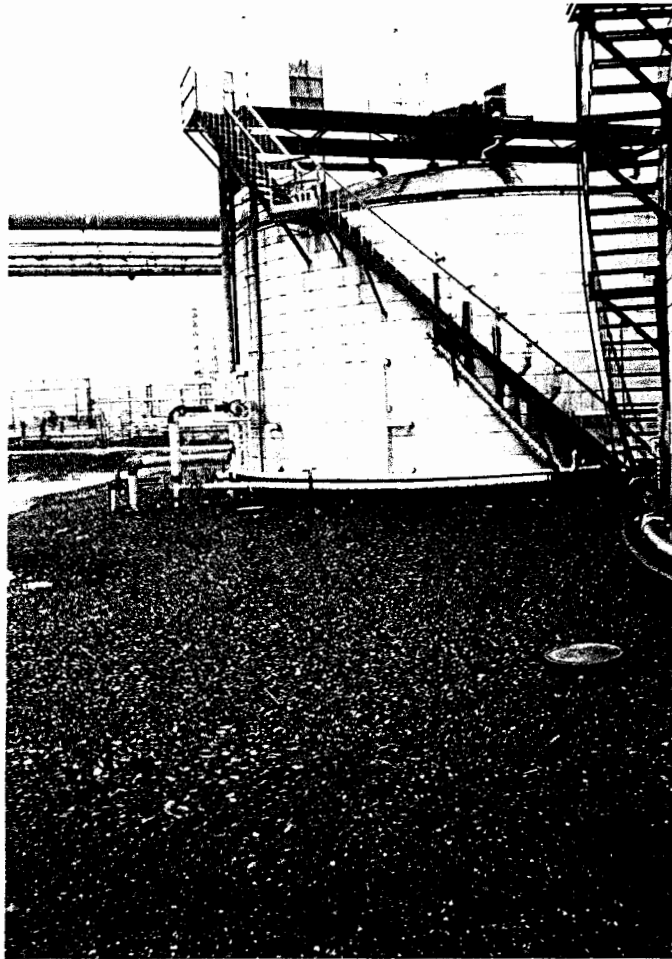
5.1

Tank No. 5 Sludge Decant Tank. View facing east. The farthest wall of the containment berm for SWMUs 4 and 5 is visible in the background of the photograph. Also, see photographs 4.2 through 4.4.

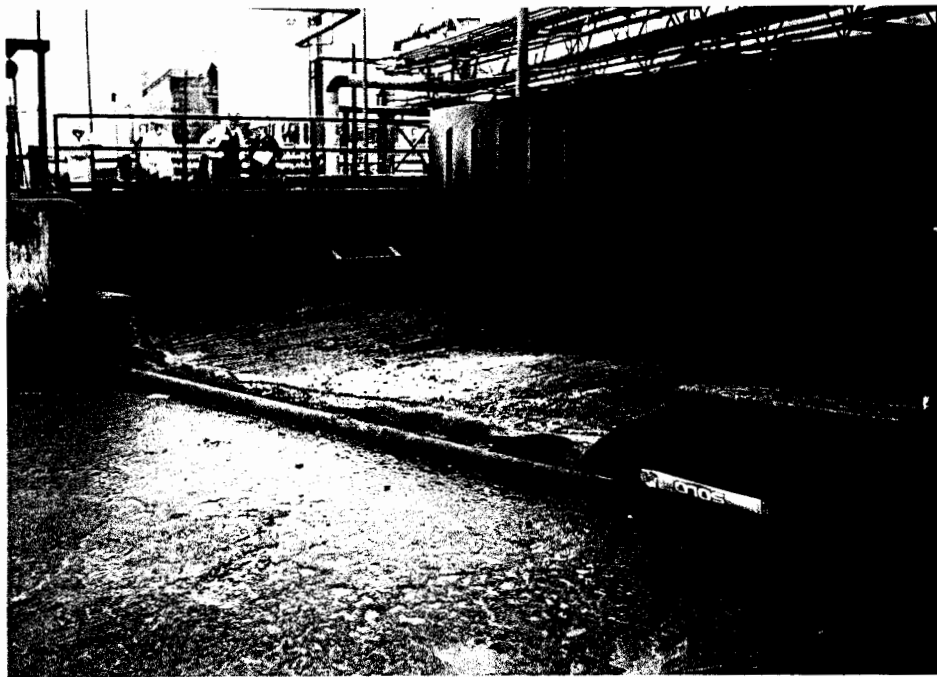
19.1 Sludge Receiving Trough. View facing north. Note the deteriorated condition of the unit and heavy, oily staining. To the left of the pad (beyond broken concrete) the bar screen and comminutor for the unit is visible.

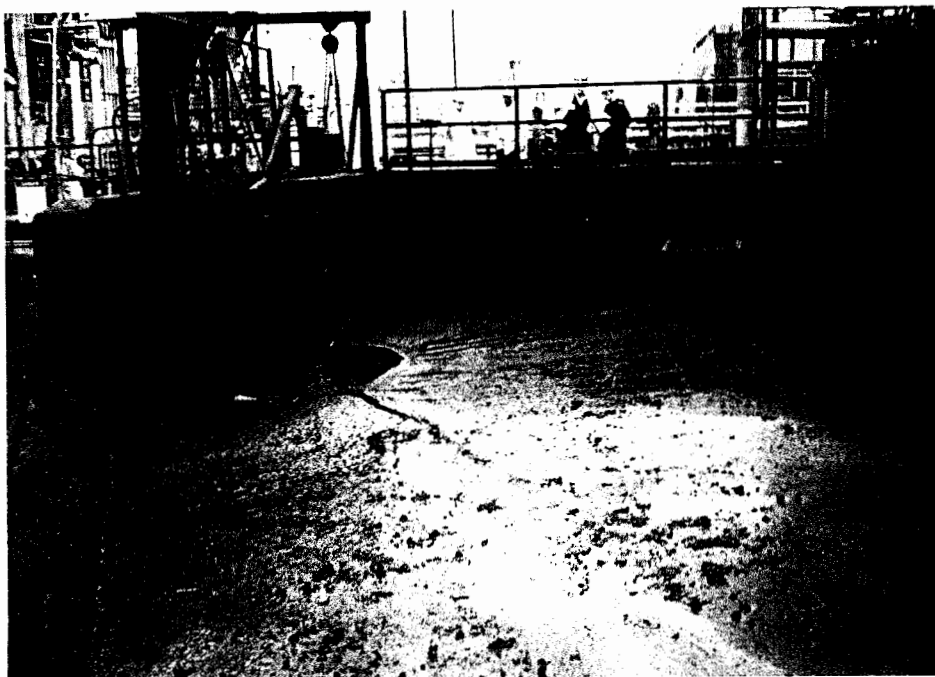
19.2 Sludge Receiving Trough. Closer view facing north of the trough (SWMU 19). The bar screen is the visible depression to the left. The box above it is the comminutor. Note the heavy oily staining on the pad.

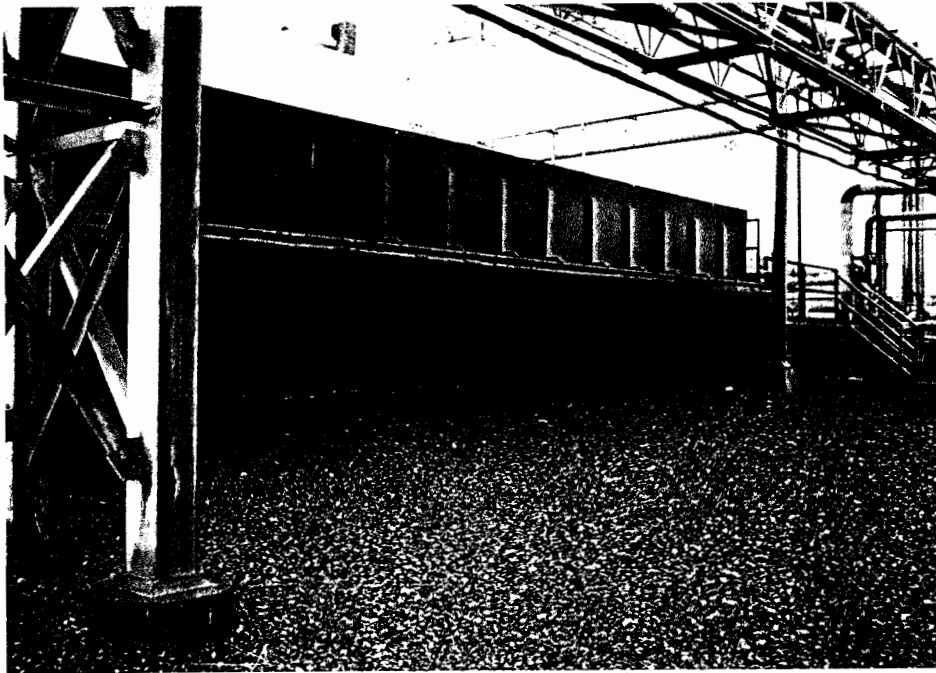
19.4 Sludge Receiving Trough. Exterior view facing northwest of the east wall of SWMU 19. Note the stains on the wall indicating a release to the ground below.

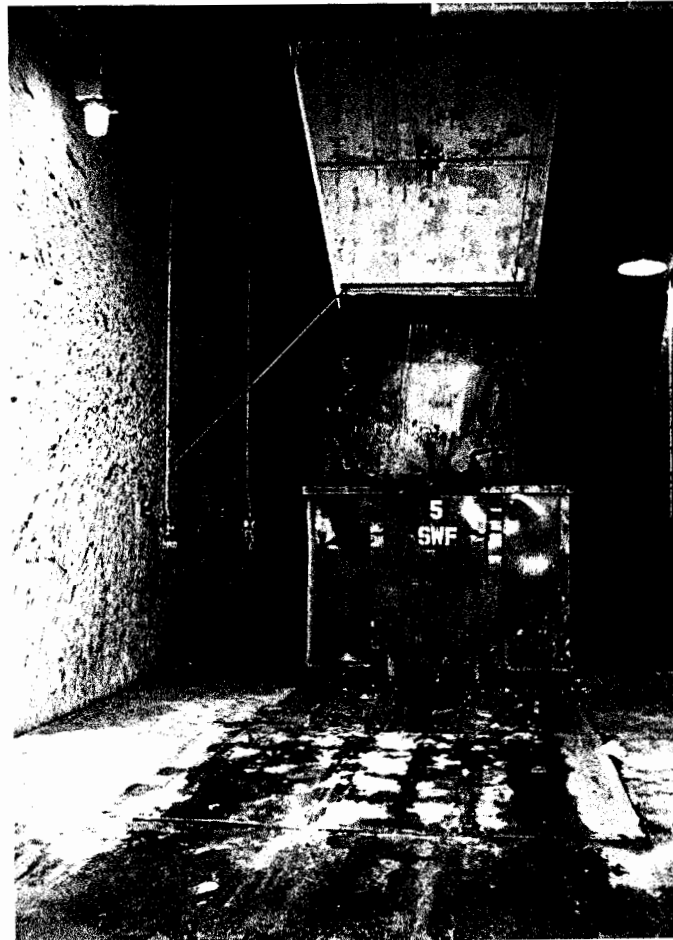
21.1 Filter Cake Knock-Out Area. View facing east toward SWMU 21 which is located directly beneath SWMU 20. Note staining and condition of the unit.

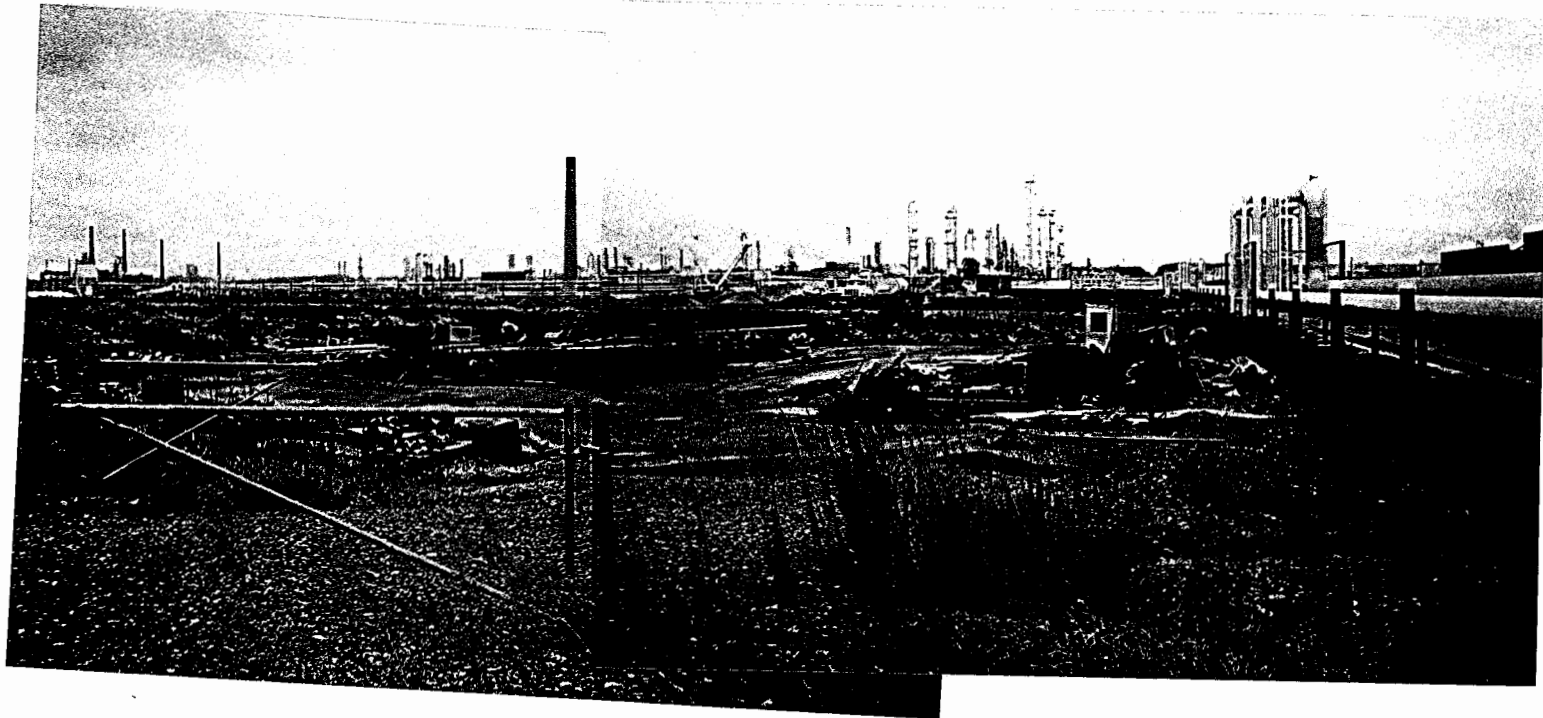
28.1 Phillips Island Maintenance Storage Area. View facing west toward an area on the island used for storing various metal valves, pipes, tubes, flanges, and connectors collected throughout the facility. Note discolored soil.

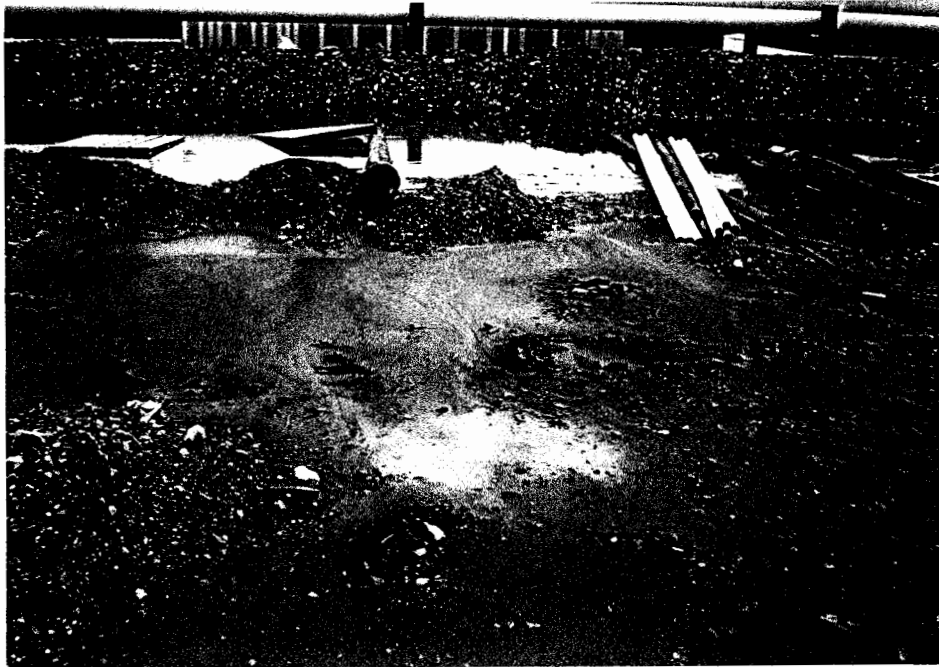
29.1 Phillips Island Roll-Off Storage Area. Close-up view of spilled spent catalyst fines visible on the ground in the roll-off area. The standing water in the photo is rainwater.

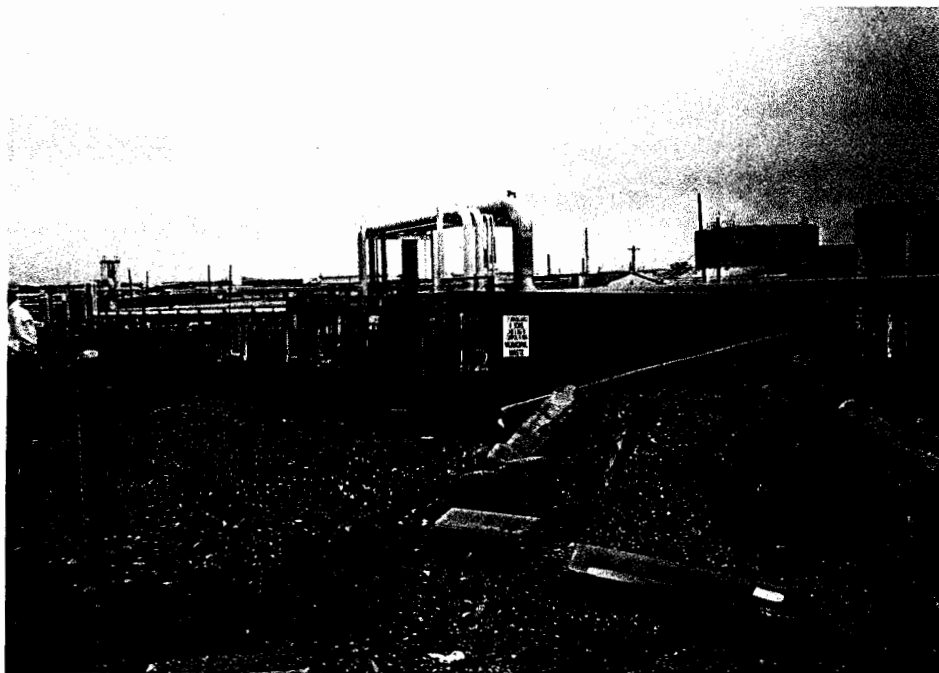
29.2 Phillips Island Roll-Off Storage Area. View facing west. Note the stained condition of the ground in the area.

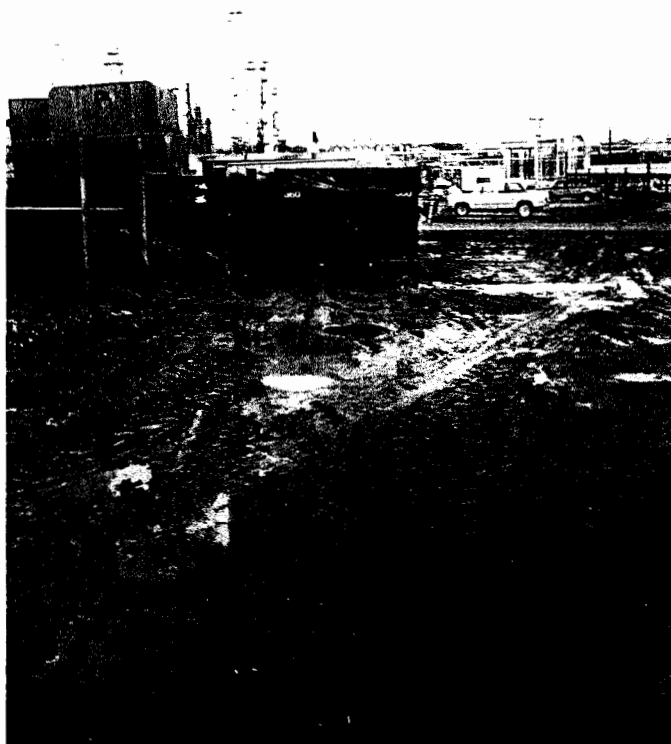
29.3 Phillips Island Roll-Off Storage Area. View facing west.
Note the spilled catalyst fines on the ground surface in
front of the roll-off bin. The fence to the left surrounds
SWMU 31.

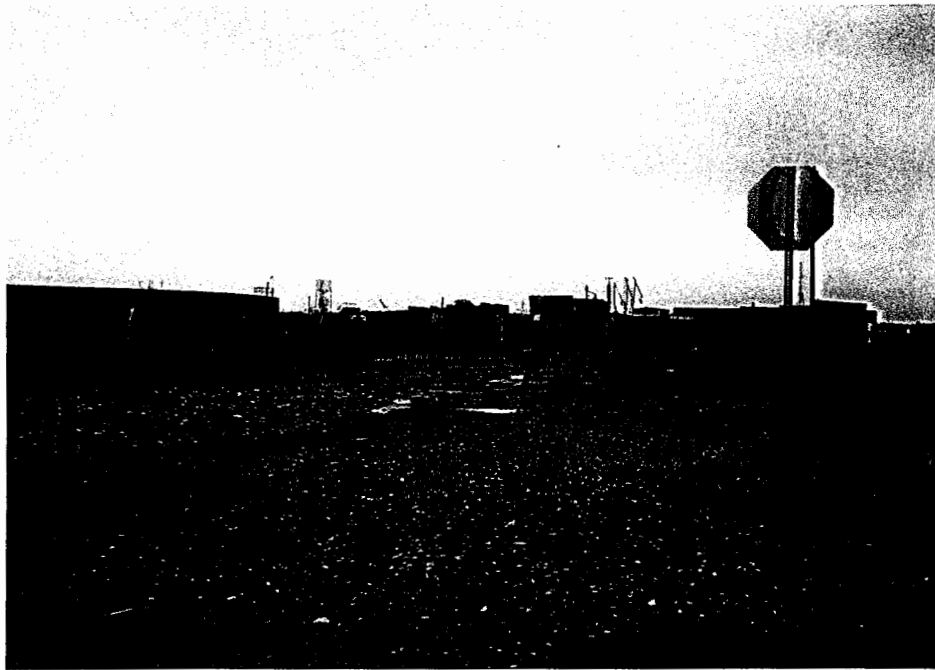
30.1 Phillips Island Old Drum Storage/Small Roll-Off Area. View facing southeast. SWMU 32 is the large concrete tank visible behind the roll-off bins. Note the stains in the areas in front of the bins.

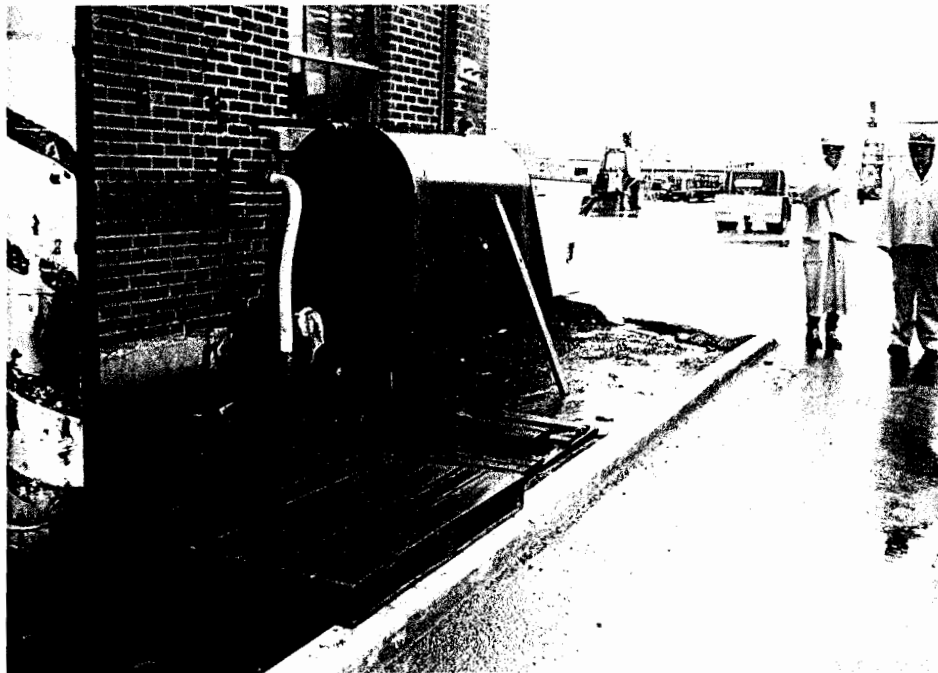
46.1 Garage Aboveground Waste Oil Tank. View facing east. The unit is located adjacent to the Garage and Maintenance Shop. Note the oily stains surrounding the unit.

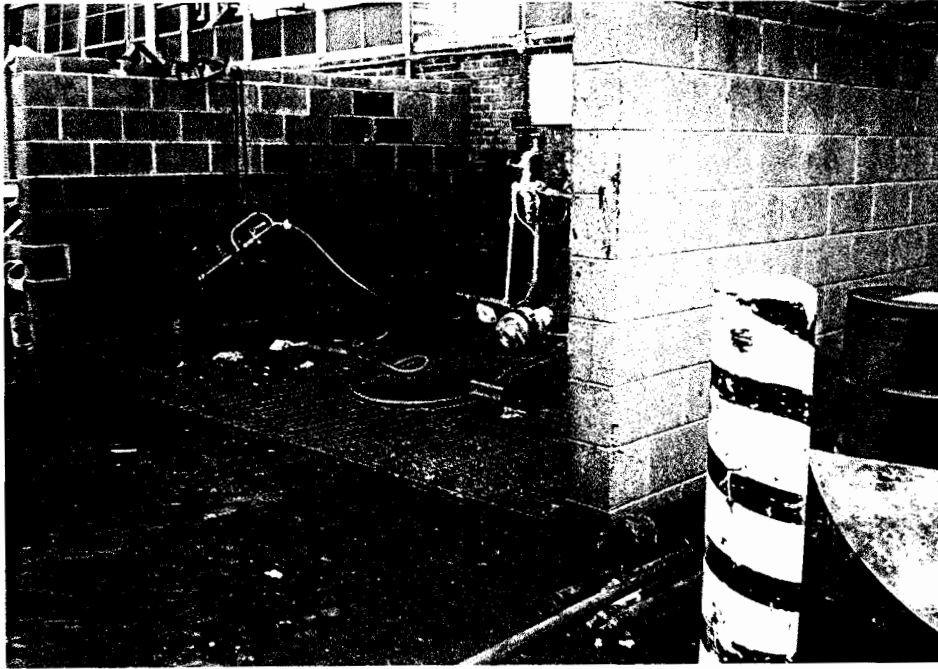
50.1 Mechanical Shop Equipment Wash Rack. View facing north. Note the heavy staining on the unit and adjacent pavement. The grate covers a sump for the unit.

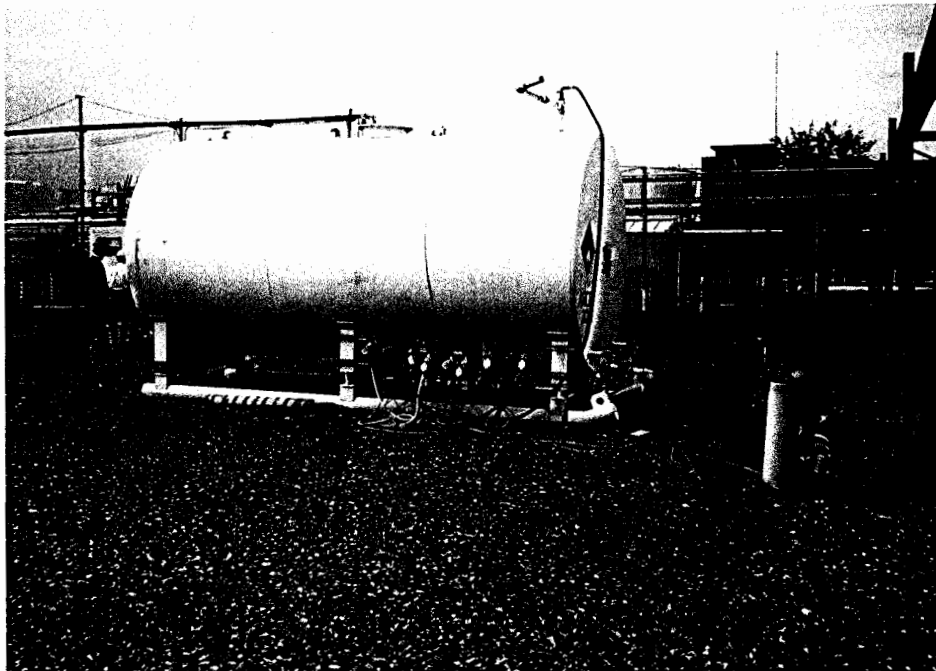
51.1 Dock No. 2 Recovery Well System. View facing north. The well is the small white PVC pipe to the right in the photograph. Water is pumped from the well to the stripping system in the larger tank. Note the stains under the tank and associated piping.

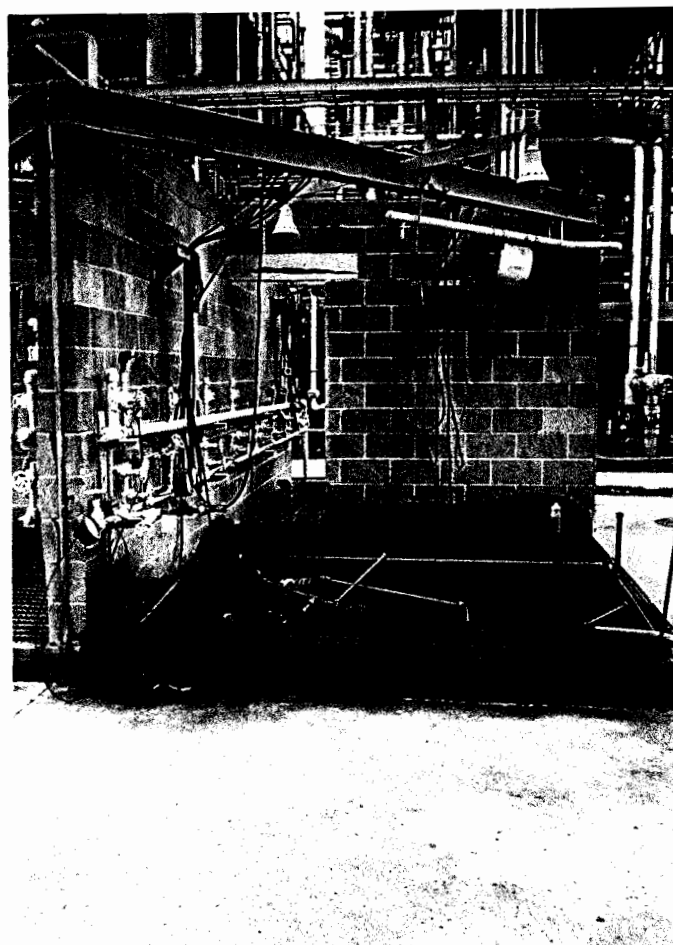
53.2 8-C Crude Unit Drip Showers. View facing south toward the north side of the drip shower (one of four compartments). Note the staining on the grate and the sump wall.

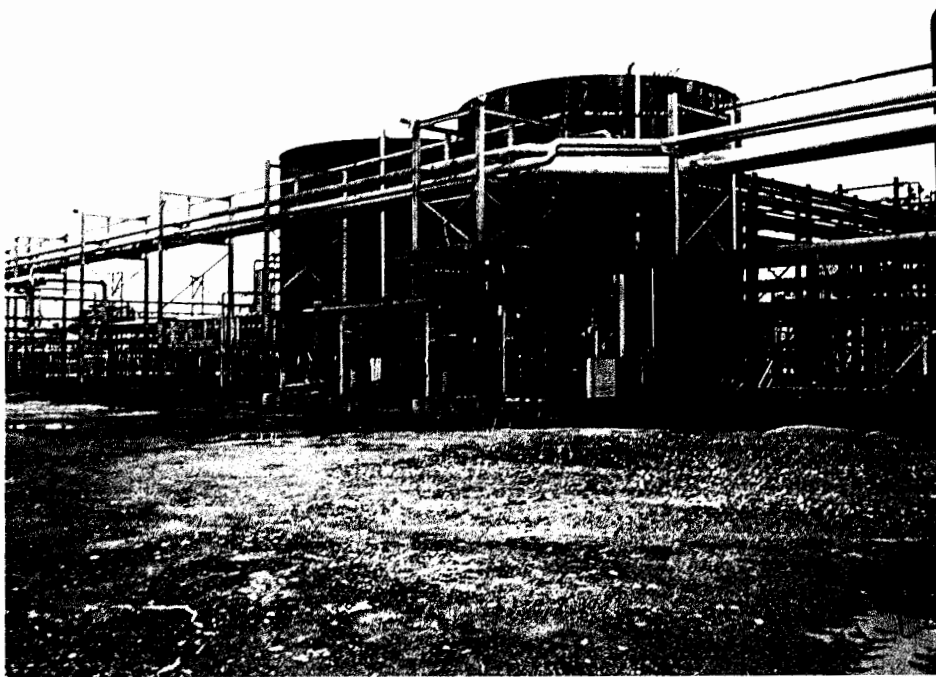
56.1 Asphalt Plant Area. View facing east. Note the oily staining on the ground surrounding the area.

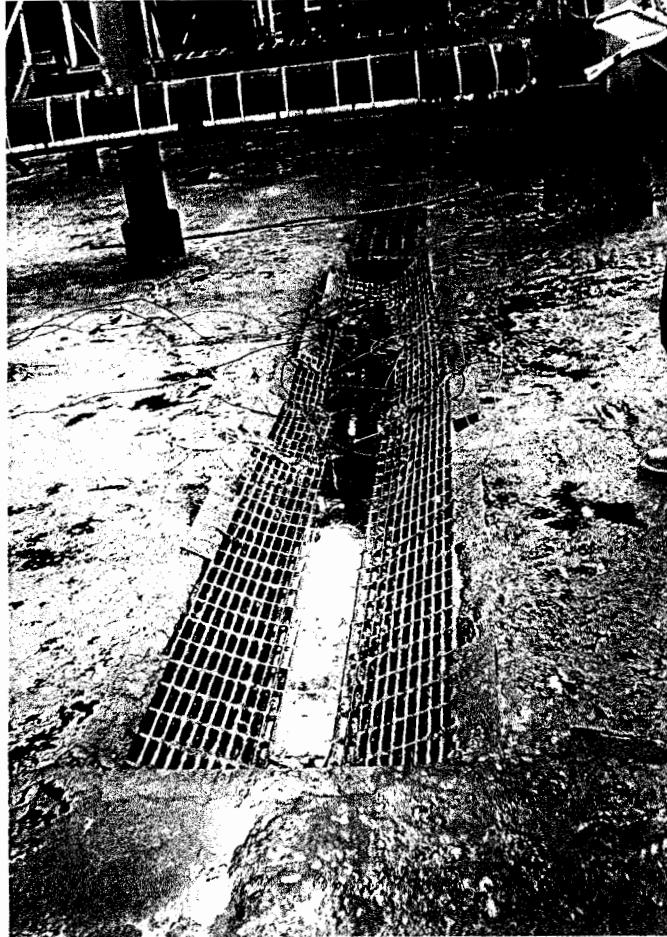
56.2 Asphalt Plant Area. View facing west toward a grated sump running the entire length of the old plant. Note the heavy oil and asphalt accumulation.

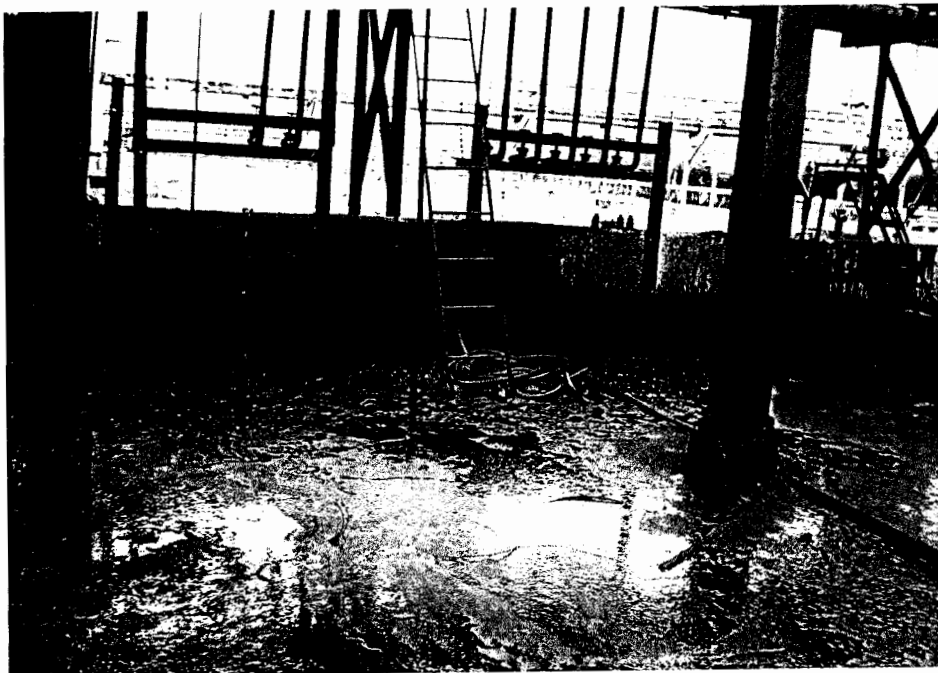
56.3 Asphalt Plant Area. View facing east toward the concrete containment wall which partially surrounds the old plant. Note the sludge-like oil and asphalt accumulation in the area.

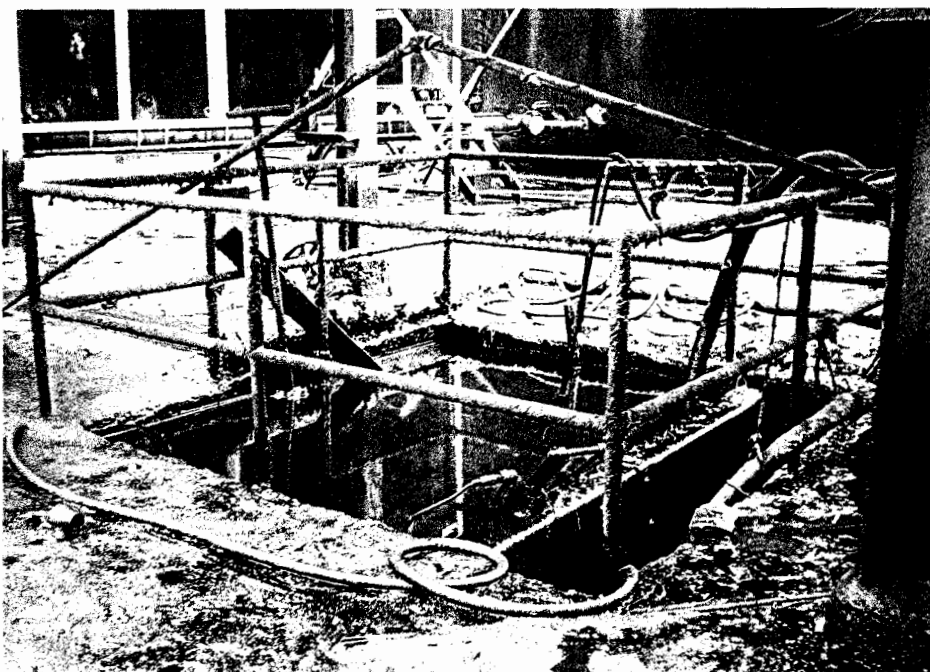
56.4 Asphalt Plant Area. View facing west toward an oil/water separator which receives discharge from the grated sump running the length of the old plant. Note the sludge-like oil and asphalt accumulation in the area.

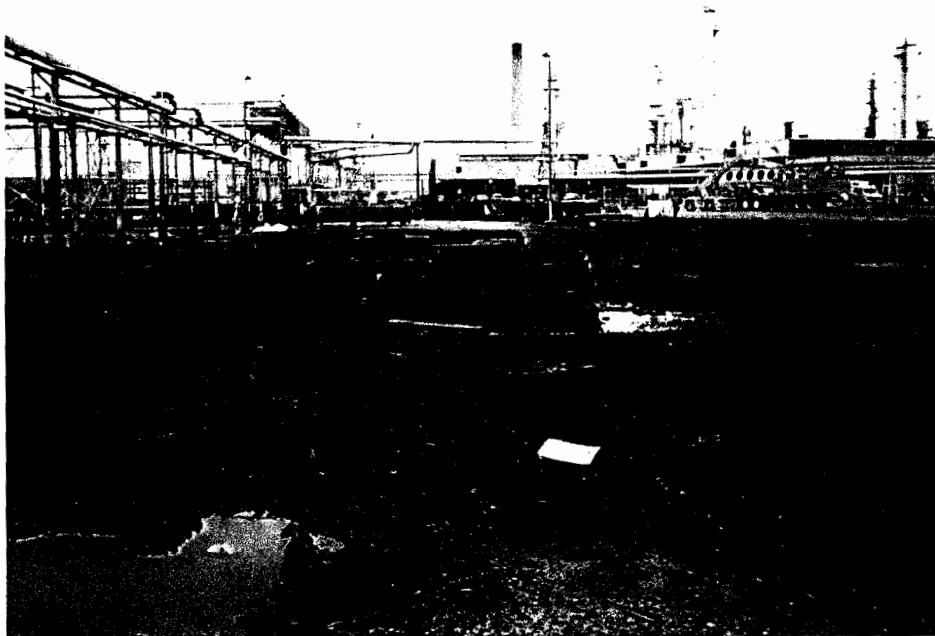
62.1 Heat Exchanger Bundle Cleaning Area. View facing west of the bundle cleaning area. Portions of the area are paved with concrete. Note the heavy staining in the area.

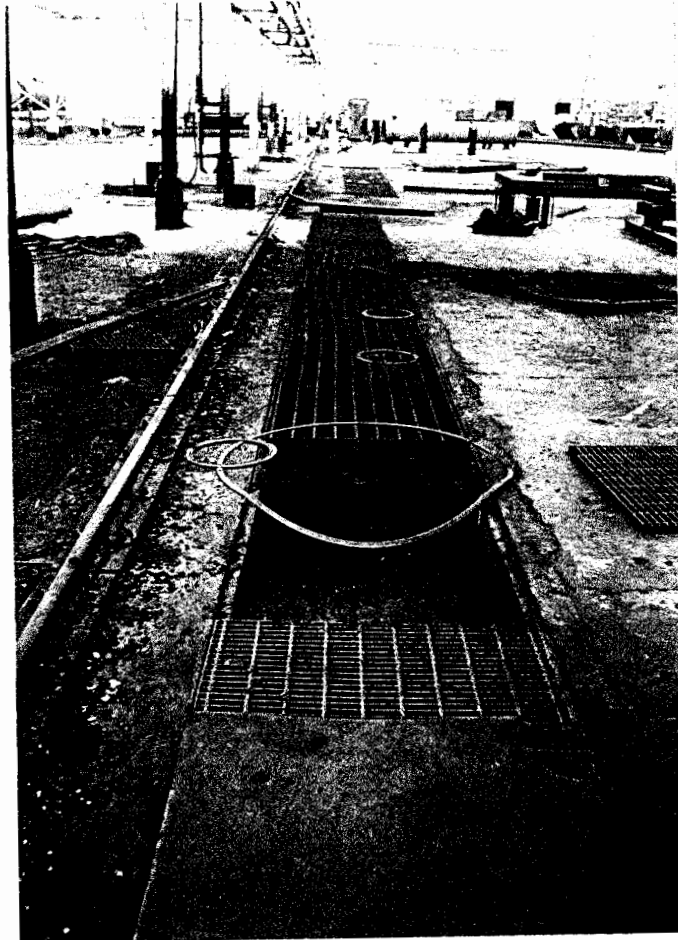
62.2 Heat Exchanger Bundle Cleaning Area. View facing west of the grated, blind sump on the south side of the unit. Note the condition of the sump and the heavy staining and oily material accumulation.

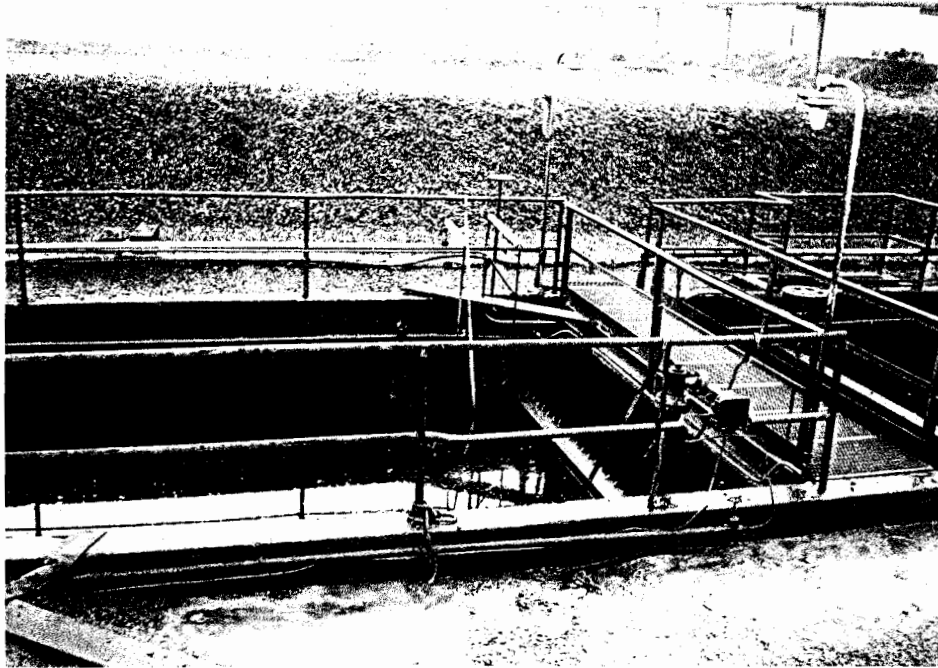
63.1 1A Oil/Water Separator. View facing east toward the middle section of the separator. Note the oily accumulation on the soil around the unit.

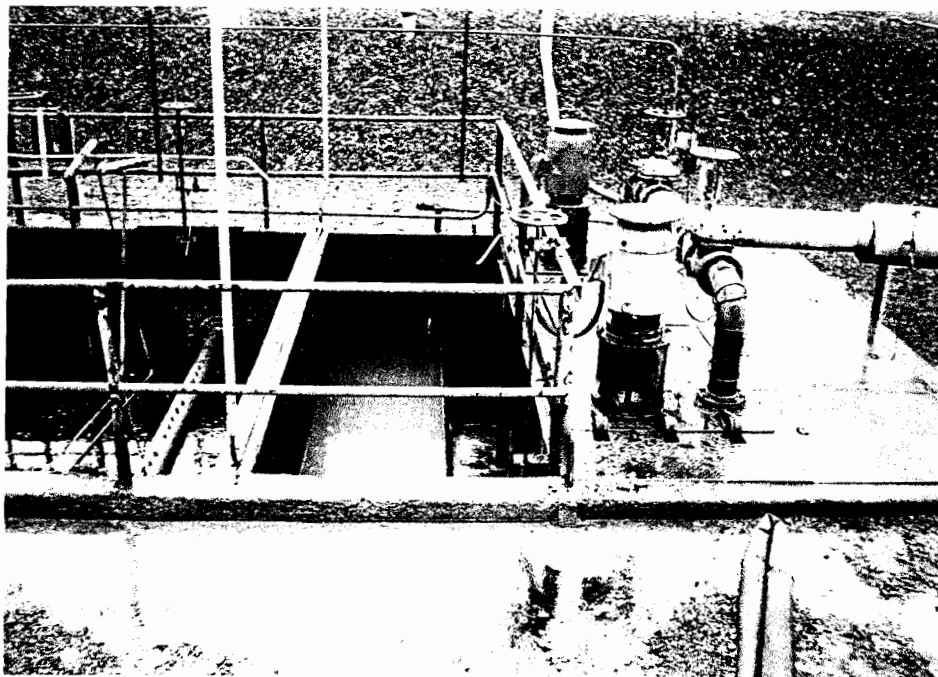
63.2 1A Oil/Water Separator. View facing northeast toward the weir and pump for the separator. Note the heavy oil accumulation on the soil around the unit.
